EMBU COUNTY GOVERNMENT

FINANCE & ECONOMIC PLANNING ANNUAL PROGRESS REPORT 2017/2018

AUGUST, 2018

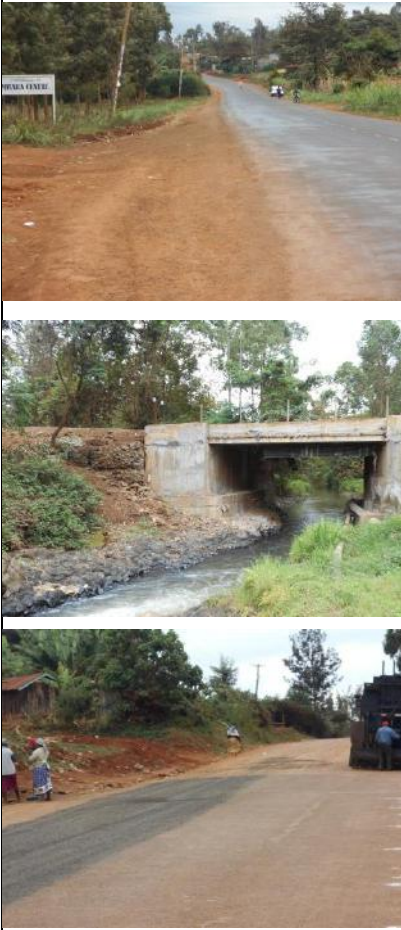
Project Description	Allocation 2017/18	Expenditure	Status	Observations	Recommendations
INFRASTRUCTURE, PUBLIC WORKS, HOUSING AND ENERGY					
Kibugu road

0.00	138,423,247	The road tarmacking is ongoing.	<ul style="list-style-type: none"> ✓ The road is contracted to 3 different contractors ✓ The drainage system on both sides of the road is partially done ✓ Large sections of the road are missing culverts ✓ The road is not 	<ul style="list-style-type: none"> ✓ The water drainage system should be constructed on both sides of the road ✓ Culverts should also be put in place especially for easier road accessibility by the community ✓ Road marking should take into consideration areas dangerous

Project Description	Allocation 2017/18	Expenditure	Status	Observations	Recommendations
				<p>properly marked. The central yellow line is broken in major sections</p> <p>✓ Bumps have been erected by the community</p> <p>✓ Guards rails are missing on both sides of the river bridge</p> <p>✓ Soil erosion is evident on a slope next to the bridge</p>	<p>for overtaking</p> <p>✓ Guard rails need to be constructed on both sides of the bridge</p> <p>✓ A stone embankment should be put in place to check against soil erosion</p>

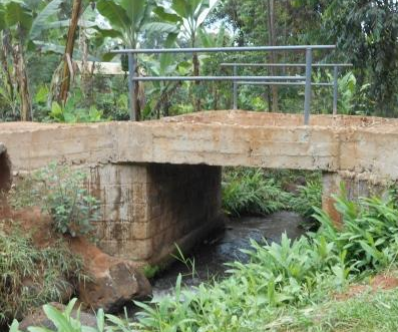
Project Description	Allocation 2017/18	Expenditure	Status	Observations	Recommendations
Ruthika bridge

0.00		✓ The bridge is complete	✓ The road connecting the bridge is in poor condition.	The road connecting the bridge needs to be murramed
Kang'ethia road

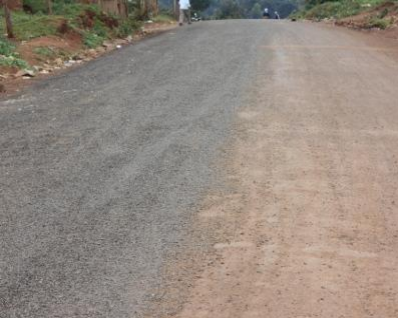
0.00		✓ The road is partially tarmacked with 550m tarmacked pending another 650m	✓ The drainage system is not in place ✓ The project does not have an allocation for road bumps	✓ A proper water drainage system should be put in place ✓ Road bumps should be erected on sections of the road that have high human traffic
EDUCATION, SCIENCE AND TECHNOLOGY

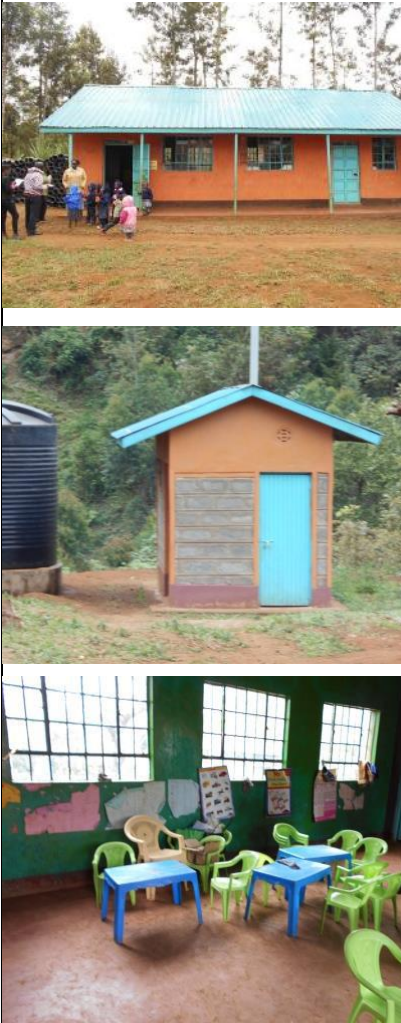
Project Description	Allocation 2017/18	Expenditure	Status	Observations	Recommendations
<p data-bbox="201 306 367 331">Ngerwe ECDE</p>

300,000.00	1,575,529.00	<ul style="list-style-type: none"> ✓ The ECDE class is complete and operational ✓ The Toilets have also been constructed 	<ul style="list-style-type: none"> ✓ The land was purchased by the county ✓ The class has 9 boys and 9 girls ✓ The ECDE is yet to receive any milk under the milk feeding programme ✓ The teacher in the facility is a volunteer ✓ The black board is not properly painted ✓ The facility should be fenced 	<ul style="list-style-type: none"> ✓ The ECDE should be factored in the milk feeding programme ✓ The facility teacher should be employed by the County on permanent and pensionable terms ✓ The facility should be fenced and fitted with a gate ✓ There is need for a proper kitchen ✓ Additional furniture as well as playing materials should be purchased ✓ Kes. 300,000 has been allocated towards fencing of compound

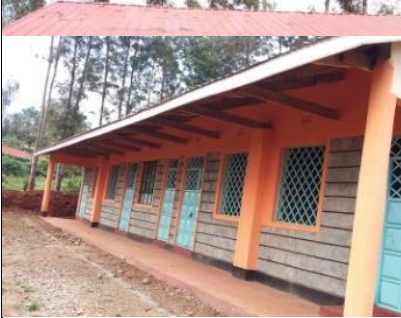
Project Description	Allocation 2017/18	Expenditure	Status	Observations	Recommendations
<p data-bbox="203 380 578 443">Muvandori vocational training centre</p>

800,000.00	2,876,076.84	The building is complete and comprises of 2 classrooms and 1 office but is not operational	The office requires ceiling installation Electricity wiring is not in place as well as an electricity connection	<p data-bbox="1239 380 1390 478">The facility requires the following:</p> <ol data-bbox="1239 485 1417 940" style="list-style-type: none"> <li data-bbox="1239 485 1417 527">1. Fencing and a gate <li data-bbox="1239 548 1417 590">2. Workshop <li data-bbox="1239 590 1417 653">3. Washrooms <li data-bbox="1239 653 1417 716">4. Landscaping <li data-bbox="1239 716 1417 835">5. Water connectivity <li data-bbox="1239 835 1417 940">6. Equipments and furniture <p data-bbox="1239 947 1417 1297">✓ A total amount of KES. 500,000 has been allocated towards construction of latrines.</p> <p data-bbox="1239 1304 1417 1577">✓ A further KES. 300,00 has been allocated towards fencing of the facility</p>

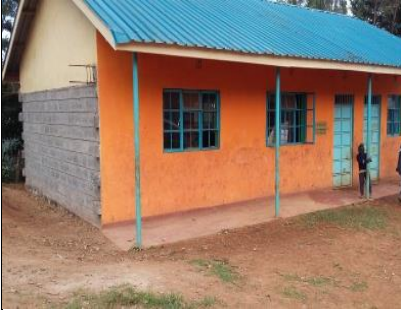
Project Description	Allocation 2017/18	Expenditure	Status	Observations	Recommendations
Rugumu ECDE centre

0.00	1,112,395.00	✓ The facility is complete	✓ The building is currently hosting 30 pupils ✓ The facility lacks ECDE toilets ✓ Furniture is required	✓ Toilets are required ✓ Furniture should be provided
Mbuvari ECDE centre

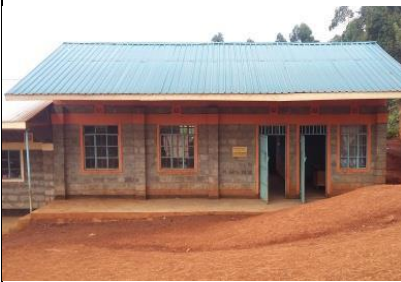
0.00	925,993.00	✓ The facility is complete	✓ There are no ECDE toilets ✓ There are no playing equipment and proper furniture	✓ Toilets are required ✓ Furniture and playing materials should be provided
St. Mark Rutune ECDE centre

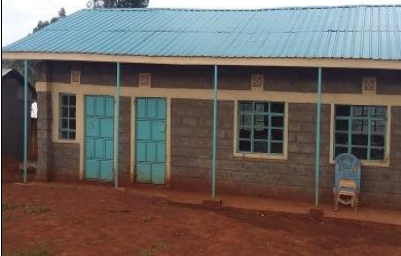
0.00	2,224,754.00	✓ The facility is complete	✓ The building is complete but not operational ✓ There are no specific ECDE toilets ✓ There are no playing	✓ Toilets are required ✓ Furniture and playing materials should be provided

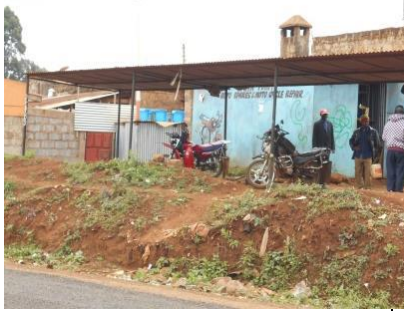
Project Description	Allocation 2017/18	Expenditure	Status	Observations	Recommendations
				equipment and proper furniture	
TRADE, TOURISM, INVESTMENT AND INDUSTRIALIZATION					
Kibugu Bodaboda shed

0.00	100,000.00	✓ The shed is complete and in use	✓ The flooring is murramed ✓ Bodabodas in the market are many hence an extra bodaboda shed is required	✓ The flooring should be murramed ✓ The is need for a standardized bodaboda shed design that has a concrete flooring/ murramed with a sitting area ✓ one extra bodaboda shed should be erected in Kibugu market
Kibugu market

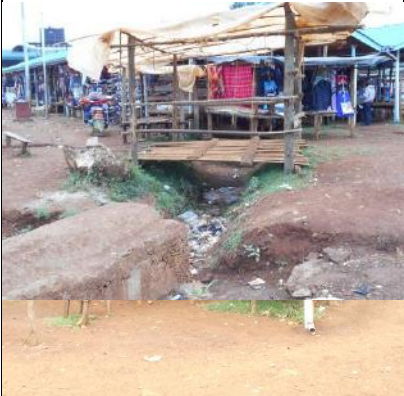
0.00	2,510,472.15	✓ The market structure is complete and properly roofed	✓ The storm water drainage runs through the market ✓ The flooring is not murramed	✓ A proper water drainage system should be put in place ✓ Electricity lighting should be provided in the market

Project Description	Allocation 2017/18	Expenditure	Status	Observations	Recommendations
				<ul style="list-style-type: none"> ✓ The market is not fenced 	<ul style="list-style-type: none"> ✓ Water connection should be provided with a tank for storage ✓ Toilets should also be constructed ✓ Market flooring should be murramed
Kibugu Market and hospital floodlights

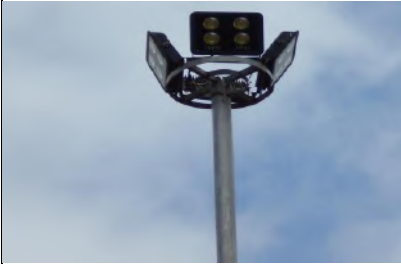
0.00		<ul style="list-style-type: none"> ✓ The two floodlights have been properly erected 	<ul style="list-style-type: none"> ✓ The Kibugu market floodlight is faulty while that of the hospital is in good working condition 	<ul style="list-style-type: none"> ✓ The faulty Kibugu market floodlight should be fixed
Kathangariri market floodlight

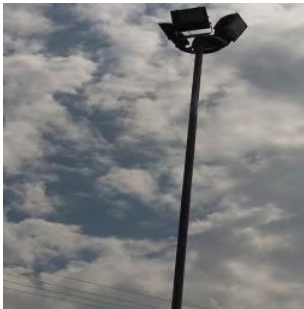
0.00		<ul style="list-style-type: none"> ✓ Complete and operational 	<ul style="list-style-type: none"> ✓ The roads in Kathangariri are poorly done ✓ The main market road is 	<ul style="list-style-type: none"> ✓ Roads within the market should be murramed ✓ A market shed should be constructed within the market

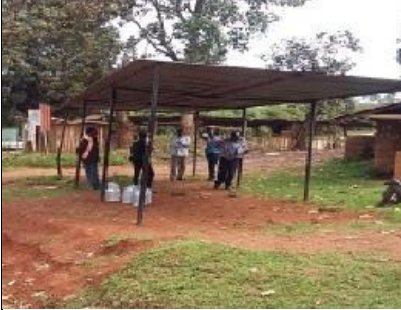
0.00	100,000.00	✓ The shed is complete	✓ The facility was constructed in the wrong location ✓ Roofs are leaking	✓ Construction of such facilities should be in consultation with the stakeholders i.e. bodaboda riders ✓ A new bodaboda shed should be constructed with consultation with users
Mbuvari bodaboda shed

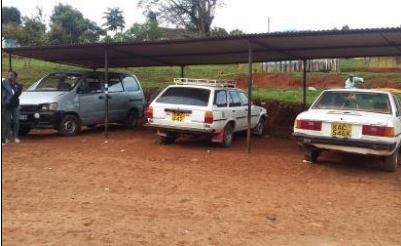
0.00	100,000.00	✓ The shed is complete and in use	✓ The floor is not murramed	✓ The flooring should be murramed

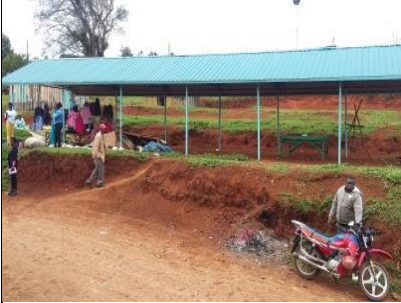
Project Description	Allocation 2017/18	Expenditure	Status	Observations	Recommendations
<p>Mbuvori market shed</p>

1,000,000.00	998,671.95	✓ The structure is complete but is underutilized	<ul style="list-style-type: none"> ✓ The floor is not murramed ✓ The market is not fenced 	<ul style="list-style-type: none"> ✓ Market toilets should be constructed ✓ Market floor should be murramed <p>Note: Funds have been allocated towards construction of market shed yet the existing structure is underutilized</p>
<p>Mbuvori market floodlight</p>

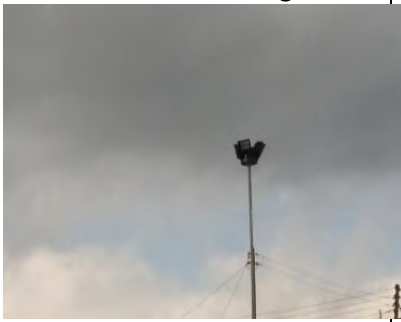
✓ Complete	✓ The floodlight is faulty	✓ The lighting bulbs should be replaced
GENDER, CULTURE AND SOCIAL SERVICES

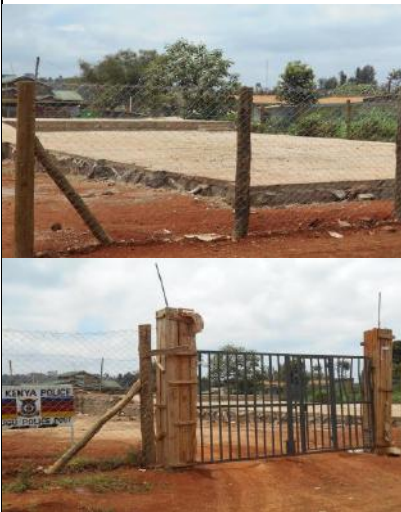
Project Description	Allocation 2017/18	Expenditure	Status	Observations	Recommendations
Kibugu social hall

0.00		<ul style="list-style-type: none"> ✓ The foundation has already been done ✓ The facility has been fenced and has a gate 	<ul style="list-style-type: none"> ✓ There is controversy on ownership ✓ There is no signage 	<ul style="list-style-type: none"> ✓ Proper signage should be in place ✓ There is need to fast-track the implementation of the facility ✓ No funds were allocated in FY 2017/18 towards construction
HEALTH					
Kibugu health centre: 1. Kitchen

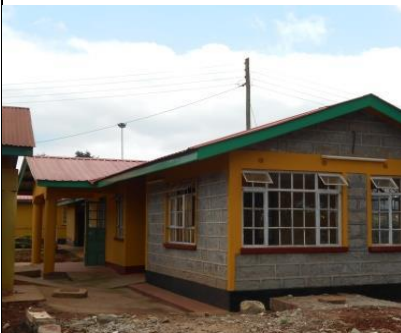
0.00	1,394,946.12	<ul style="list-style-type: none"> ✓ Kitchen is complete with water and electricity 	<ul style="list-style-type: none"> ✓ The kitchen is fully done awaiting equipping 	<ul style="list-style-type: none"> ✓ Equipping of kitchen should be fast-tracked

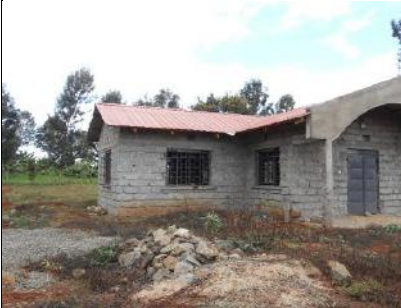
2. Mini Theatre			<ul style="list-style-type: none"> ✓ Mini theatre sub-structure is done, roofing, windows and door 	<ul style="list-style-type: none"> ✓ The mini-theatre plastering is poorly done; ✓ The contractor is 	<ul style="list-style-type: none"> ✓ A technical assessment is required to ascertain the required standards have been

installation	<ul style="list-style-type: none"> not on site ✓ Painting has not been done ✓ The ceiling has not been installed ✓ No water connection ✓ No internal washrooms ✓ Flooring is poorly done ✓ 	<ul style="list-style-type: none"> adhered to. ✓ The internal design of the theatre should be redone in consultation with facility administration ✓ Enough resources should be allocated towards completion ✓ New staff washrooms should be constructed <p>Note: No funds have been allocated in FY 2017/18 towards completion of facility</p>
<p>Kangethia dispensary</p>

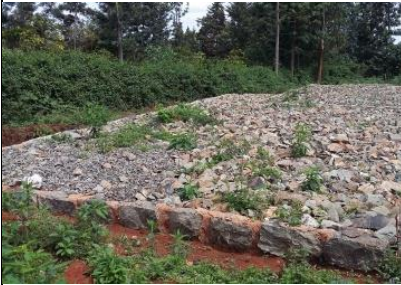
3,800,00 0.00	0.00	✓ At foundation level	<ul style="list-style-type: none"> ✓ There are no materials on site ✓ The contractor is not on site 	<ul style="list-style-type: none"> ✓ The project should be allocated enough resources to fastback completion

Project Description	Allocation 2017/18	Expenditure	Status	Observations	Recommendations
				<ul style="list-style-type: none"> ✓ No fence or gate in place ✓ No signage 	<ul style="list-style-type: none"> ✓ The facility should be fenced and a gate installed ✓ A signage should be put in place <p>Note: Funds have allocated in FY 2017/18 towards completion, fencing and equipping of facility</p>
AGRICULTURE & IRRIGATION, LIVESTOCK, FISHERIES AND CO-OPERATIVE DEVELOPMENT					
<p>Kibugu milk cooler</p>

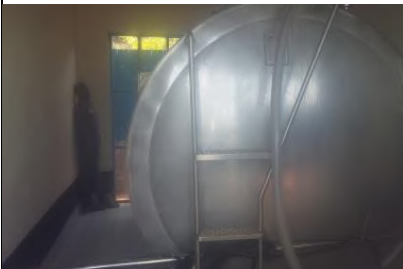
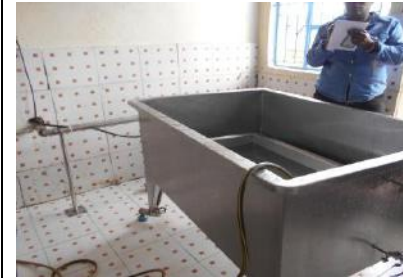
0.00		<ul style="list-style-type: none"> ✓ The machines are fully installed and are operational 	<ul style="list-style-type: none"> ✓ The cooler was given to Kibugu Farmers CBO ✓ The facility collects about 4,300 litres on daily basis 	<p>The facility is properly utilized</p>

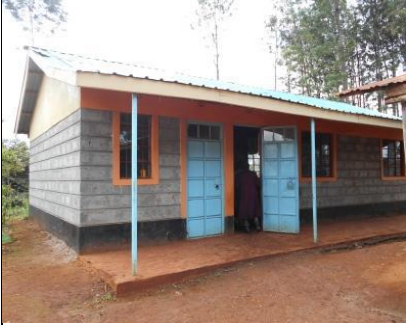
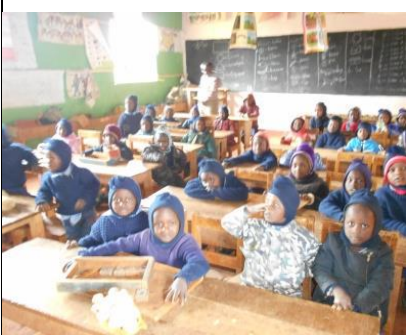
Project Description	Allocation 2017/18	Expenditure	Status	Observations	Recommendations
EDUCATION, SCIENCE AND TECHNOLOGY					
Kenga ECDE centre

0.00	925,761.20	✓ The facility is complete	✓ The facility is complete and is operational ✓ The facility is currently hosting 39 pupils ✓ There are no ECDE toilets ✓ There are no playing equipment and proper furniture ✓ No electricity Connection	✓ Toilets are required ✓ Furniture and playing materials should be provided ✓ A kitchen should be constructed

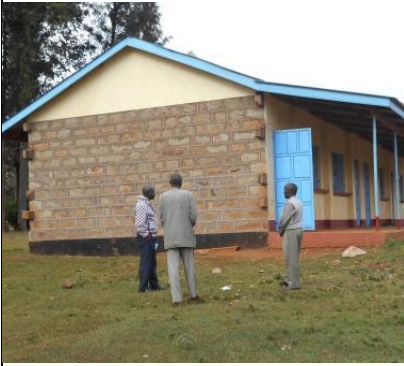
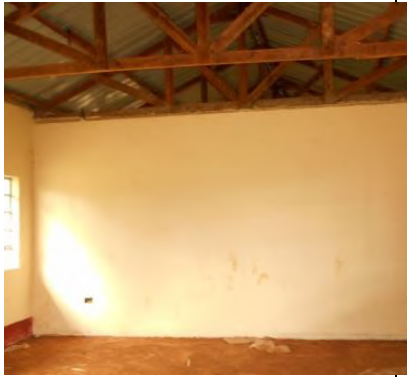
Project Description	Allocation 2017/18	Expenditure	Status	Observations	Recommendations
Kamviu polytechnic classrooms

0.00	1,262,556.70	✓ The renovation of 2 classrooms and 1 office is complete	✓ There are no toilets available for staff members and students ✓ The facility is not fenced and does not have a gate	✓ New toilets should be constructed ✓ The facility should have an independent gate and fence from that of the primary school
INFRASTRUCTURE, PUBLIC WORKS, HOUSING AND ENERGY					
Kyungu-Rwere road	0.00		✓ 2 Km have been murramed	✓ The road is passable	✓ Additional murraming is required
Kiriari-Kyunyu bridge	0.00		✓ The bridge is complete	✓ The bridge is passable but has	✓ Erosion should be controlled through back filling

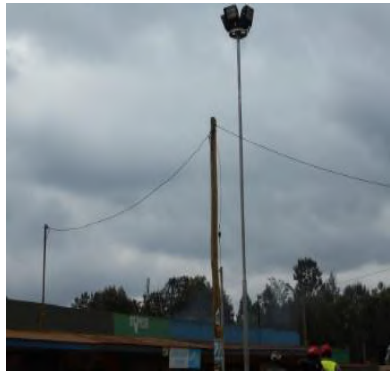
0.00		✓ The floodlight is properly erected	✓ The floodlight is fully operational	✓ There is need for a market shed at Kiriari
Kiriari bodaboda shed

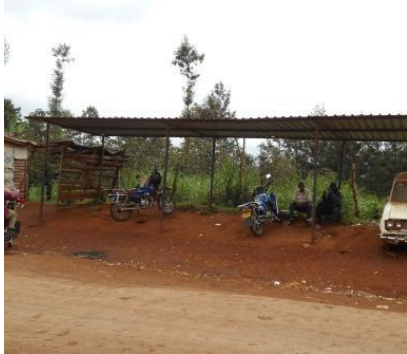
100,000.00	100,000.00	✓ The shed is complete	✓ The flooring is poorly done ✓ The roof is leaking	✓ The shed requires levelling and murraming ✓ A front leaning roof is needed to guard against rain

Project Description	Allocation 2017/18	Expenditure	Status	Observations	Recommendations
					<ul style="list-style-type: none"> ✓ The roof should be repaired ✓ Additional bodaboda sheds should be constructed <p>Note: KES 100,000 has been provided in FY 2017/18 budget for construction of another bodaboda shed</p>
Kiriari market toilets

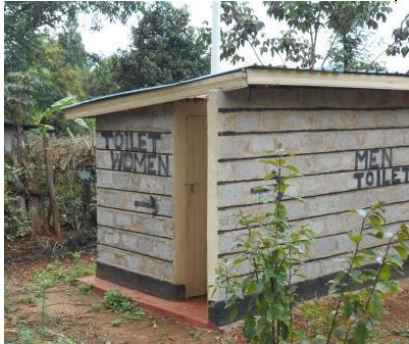
0.00		✓ The toilets are complete	✓ There toilets comprise of 1 male toilet, 1 female toilet and 1 urinal	✓ The toilets are complete and in use
Manyatta open air market

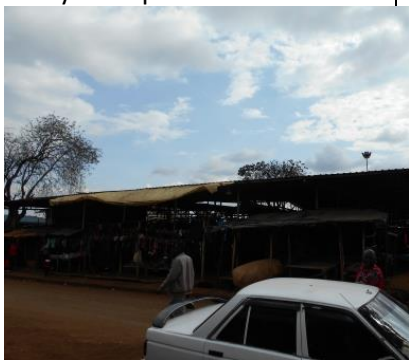
2,000,000.00		✓ Phase 1 of the market is complete	✓ The market is properly roofed but requires murraming of the flooring	<ul style="list-style-type: none"> ✓ The market should be fenced and murramed ✓ Market toilets should be constructed <p>Note: A further KES. 2,000,000 has been allocated in FY 2017/18</p>

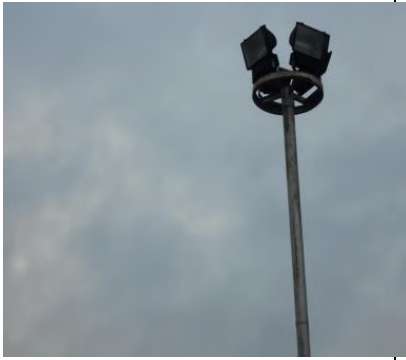
0.00		✓ The floodlight has been erected	✓ The floodlight is faulty	✓ The lighting mast should be repaired
HEALTH

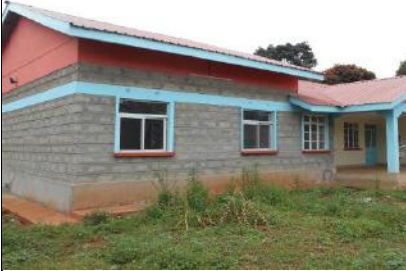
Project Description	Allocation 2017/18	Expenditure	Status	Observations	Recommendations
<p>Kairuri Health Centre – Construction of Maternity</p>

9,036,798.00	5,831,987.60	✓ The facility is almost complete. The maternity is roofed, painted with only minor works remaining	<p>✓ The works are of high standards</p> <p>✓</p>	<p>✓ The standard of works should be emulated by other contractors</p> <p>✓ Landscaping works should be done</p> <p>✓ 3 tanks are required</p> <p>✓ The required equipment should be installed</p> <p>Note: Funds have been allocated in FY 2017/18 as follows:</p> <ul style="list-style-type: none"> i. Construction Of Incinerator – 1,036,798.00 ii. Equipping – 5,000,000 iii. Power backup generator – 3,000,000.00
YOUTH EMPOWERMENT AND SPORTS

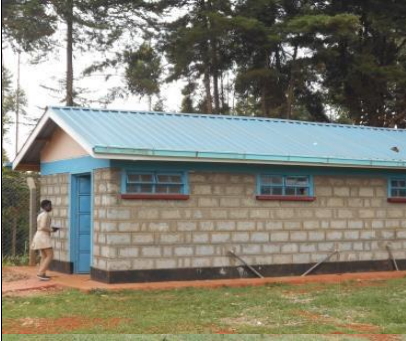
Project Description	Allocation 2017/18	Expenditure	Status	Observations	Recommendations
<p>Kairuri playground</p>

0.00		<ul style="list-style-type: none"> ✓ Fencing is complete ✓ 2 gates have already been installed ✓ Ablution block is complete 	<ul style="list-style-type: none"> ✓ The quality of works for the facility is high ✓ Door handles are missing ✓ Doors have not been painted 	<ul style="list-style-type: none"> ✓ A pavilion should be erected ✓ Door handles should be fixed ✓ The doors should be painted
AGRICULTURE & IRRIGATION, LIVESTOCK, FISHERIES AND CO-OPERATIVE DEVELOPMENT					
<p>Gakundu milk cooler</p>

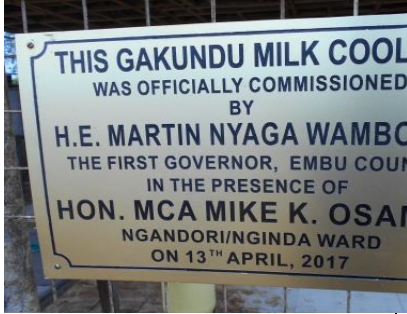
0.00		<ul style="list-style-type: none"> ✓ The project is complete and operational 	<ul style="list-style-type: none"> ✓ The equipment is being properly utilized ✓ A standby generator is in place 	<ul style="list-style-type: none"> ✓ There is need to mobilize more community members to sell their milk to the milk facility

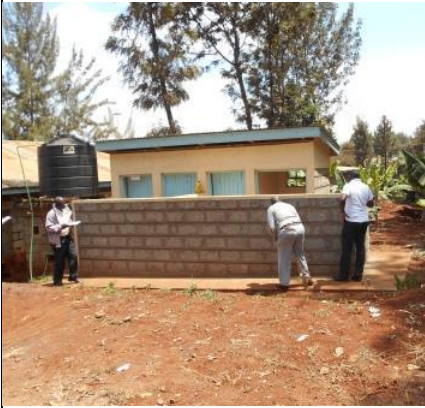
Project Description	Allocation 2017/18	Expenditure	Status	Observations	Recommendations
EDUCATION, SCIENCE AND TECHNOLOGY					
Tenri polytechnic toilets

0.00		✓ The project is complete and in use	<ul style="list-style-type: none"> ✓ There are 4 toilets (2 for women, 1 for men + urinal ✓ The toilets constructed are for staff members only 	✓ The project is complete and in use
Tenri polytechnic kitchen	0.00		✓ construction of the kitchen is	✓ it is in use by 200 students (145	✓ Cooking equipments need to be provided

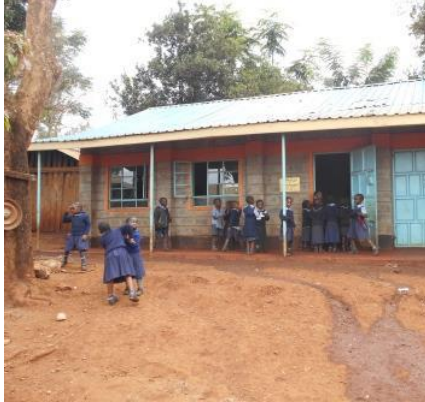
0.00	925,993.00	<ul style="list-style-type: none"> ✓ The ECDE class has been completed and commissioned 	<ul style="list-style-type: none"> ✓ They have 2 teachers employed by the county ✓ Has 74 pupils (41 girls and 33boys) ✓ 	<ul style="list-style-type: none"> ✓ Requires space for expansion and additional classes ✓ Learning materials should be purchased ✓ Land should be purchased for a playground ✓ A kitchen is needed

Project Description	Allocation 2017/18	Expenditure	Status	Observations	Recommendations
 					<ul style="list-style-type: none"> ✓ Washrooms should be constructed for ECDE pupils

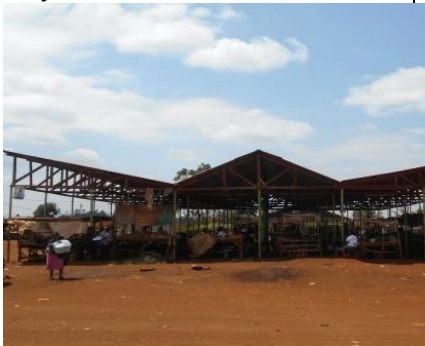
<p>Majimbo market</p>

<p>1,000,000</p>		<ul style="list-style-type: none"> ✓ The market construction is complete 	<ul style="list-style-type: none"> ✓ The market has electricity but two bulbs are not working ✓ The drainage system in the market is poor ✓ There is no water connection ✓ The market toilets are complete 	<ul style="list-style-type: none"> ✓ A perimeter fence and a gate should be constructed ✓ Water gutters should be installed ✓ Water should be provided to the community <p>Note: A further KES. 1,000,000</p>
---	------------------	--	---	--	---

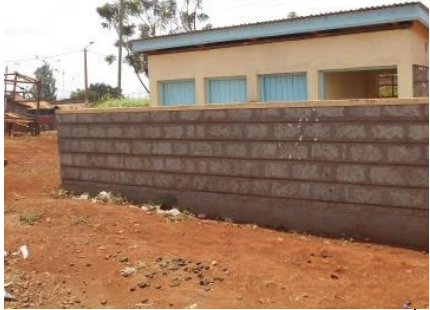
0.00		✓ The project is complete but not in use	✓ The toilets are not operational ✓ There are 4 toilets (2 for women and 1 for men + urinal) ✓ There are no window panes on the toilets	✓ Fixing of glass windows should be followed up and put ✓ The toilets need to be handed over to the community
Kambo market (Itabua)

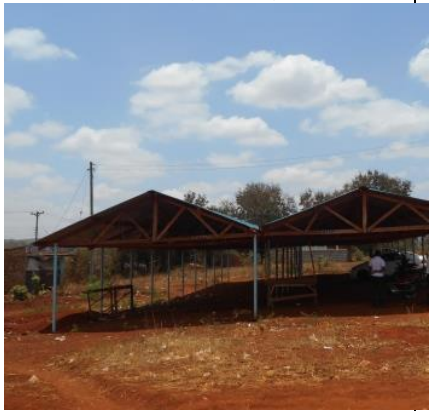
0.00	1,999,999.00	✓ It is a new market (upcoming)	✓ The structure is complete ✓ The market is not in use at the moment ✓ No slabs have been put in place and no levelling	✓ Slabs should be put in place ✓ Electricity connection should be installed ✓ Levelling of the market to be done ✓ A perimeter

Project Description	Allocation 2017/18	Expenditure	Status	Observations	Recommendations
				<ul style="list-style-type: none"> has been done ✓ There is no electricity connection ✓ The roofing has been done poorly ✓ No perimeter fence has been constructed 	<ul style="list-style-type: none"> r fence should be constructed ✓ Requires a boda boda shed of about 25-30 bodaboda ✓ A water connection should be put in place
Kambo market floodlight

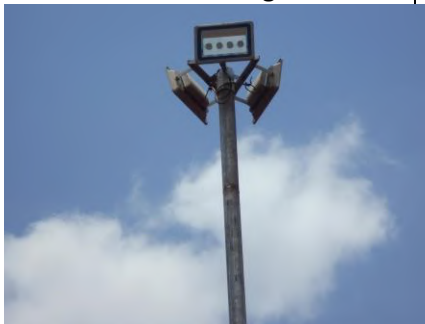
0.00		<ul style="list-style-type: none"> ✓ The floodlights are not in use (defective) 	<ul style="list-style-type: none"> ✓ The floodlights are not operational ✓ The bulbs are wrongly put, facing the sky ✓ The floodlights are not serving the community 	<ul style="list-style-type: none"> ✓ The floodlights should be repaired and fixed
Kimangaru market toilets	0.00	499,960.00	<ul style="list-style-type: none"> ✓ The toilets have 	<ul style="list-style-type: none"> ✓ There are 4 toilets 2 	<ul style="list-style-type: none"> ✓ The facility is complete

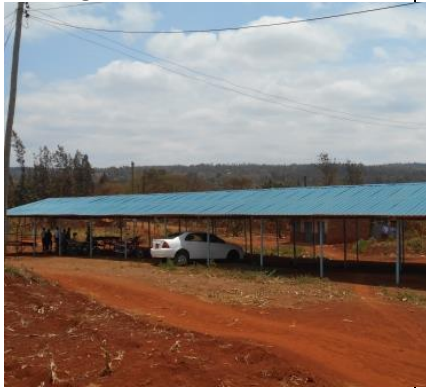
0.00	2,000,000.00	✓ The structure is complete	<ul style="list-style-type: none"> ✓ There is no electricity connection in the market ✓ There are no slabs ✓ Fencing has been done on only one side ✓ There is a working water supply system ✓ There are no gutters and no water tank for storage of water 	<ul style="list-style-type: none"> ✓ A strong perimeter fence should be constructed ✓ Electricity should be installed ✓ A water tank for storage should be provided ✓ A gate to be put in place
Kimangaru market floodlight	0.00		✓ The installation of the	✓ The floodlights are	✓ The department

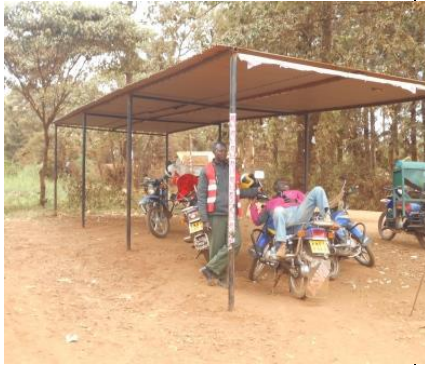
0.00		✓ The shed has been completed but not in use	<ul style="list-style-type: none"> ✓ The structure needs renovation and modification ✓ The ground has not been levelled 	✓ The shed should be levelled and a slab constructed or the floor should be murramed
<p data-bbox="203 1528 511 1560">Karurina boda boda shed</p>	0.00		✓ The shed is complete and in use	<ul style="list-style-type: none"> ✓ The shed is not murramed ✓ The community is satisfied with the site 	✓ The floor should be murramed

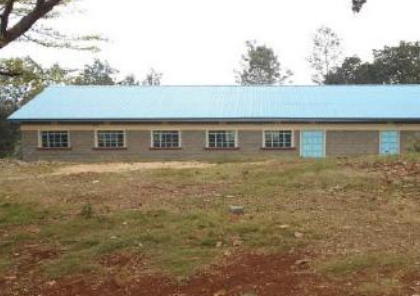
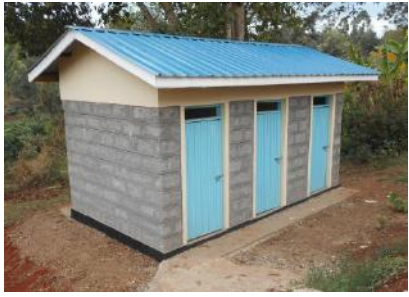
<p data-bbox="203 783 422 814">Gatituri social hall</p>

0.00		<ul style="list-style-type: none"> ✓ The social hall construction is not fully complete ✓ The toilets are complete 	<ul style="list-style-type: none"> ✓ Wiring has been done but not connected ✓ The facility has 5 toilets ,3 for women and 2 for men including a urinal 	<ul style="list-style-type: none"> ✓ A perimeter fence and gate should be constructed/ installed ✓ Water supply system should be put In place ✓ Furniture for the hall should be bought ✓ There is need for landscaping

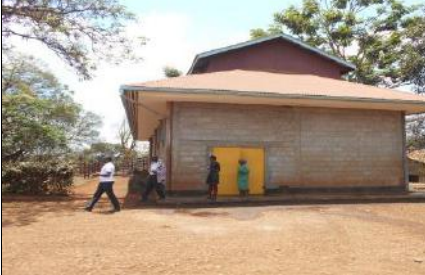
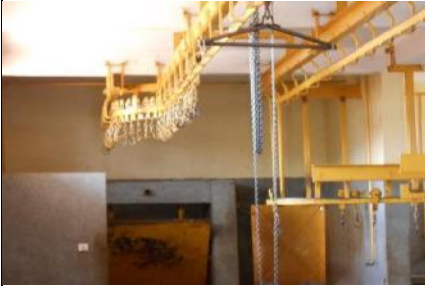
0.00		<ul style="list-style-type: none"> ✓ Renovation of slaughter house 	<ul style="list-style-type: none"> ✓ Renovation done were not as per the BQ key among them a new gate. The old gate was painted but not replaced ✓ Wrong specifications of meat rollers along the rail making it a hazard to the staffs ✓ Hot water panel was not connected despite the presence of hot 	<ul style="list-style-type: none"> ✓ A drainage system and a disposal pit is required ✓ Construction of cattle trough(holding area) is needed ✓ Hot water panel should be connected to the hot water system ✓ Need of a drainage trench slightly above the siltation open dish to protect rain water from

Project Description	Allocation 2017/18	Expenditure	Status	Observations	Recommendations
				<p>water system in the slaughter house</p> <p>✓ The open dish is not protected from rainwater</p> <p>✓ The facility is underutilized</p>	<p>entering the dish</p> <p>✓ This is major cashcow for the county if properly utilized</p>
<p>Slaughter house floodlight(majimbo)</p>

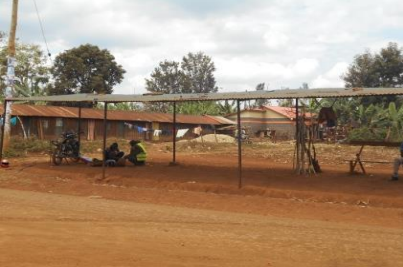
Project Description	Allocation 2017/18	Expenditure	Status	Observations	Recommendations
TRADE, TOURISM, INVESTMENT AND INDUSTRIALIZATION					
Karurina bodaboda shed

0.00		✓ The shed is complete but not in use	✓ The shed is not conducive for all seasons eg rainy seasons	✓ The bodaboda shed should be fixed and put available for all round year purposes
Nembure social hall

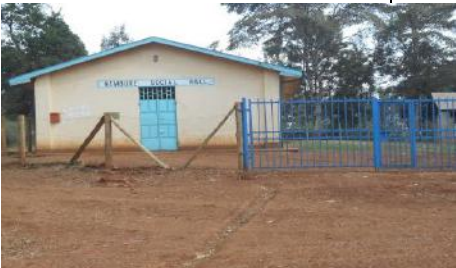
0.00		✓ The structure is complete	✓ A perimeter fence and a gate has been put in place ✓ No washrooms have been constructed	✓ Furniture is required at the hall ✓ Washrooms for both male and female need to be constructed
Karingari Market

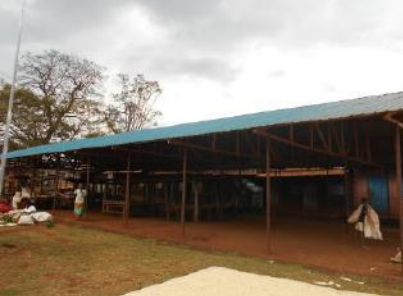
290,827.00		✓ The market is complete	✓ Murraining has not been done ✓ The market is operational	✓ A perimeter fence and a gate need to be put in place ✓ Market pillars need to be reinforced ✓ Tanks and water connection

Project Description	Allocation 2017/18	Expenditure	Status	Observations	Recommendations
					to be provided ✓ Water gutters should be installed Note: KES. 290,827 has been allocated towards murraming of the floor
Karingari market toilet

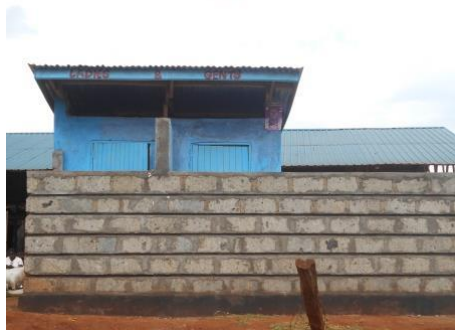
0.00		✓ The toilets are complete and in use	✓ There are 3 toilets (1 urinal and 2 toilets)	✓ The project is complete
Karingari market floodlight

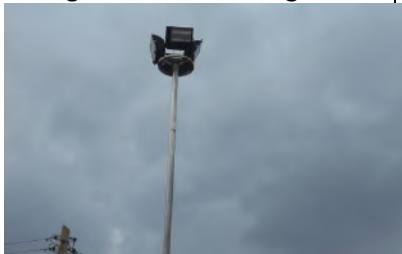
0.00		✓ The project is satisfactory	✓ The lights are in good condition and the lighting is good	✓ The project is okay
Karingari bodaboda shed	0.00		✓ The shed needs renovation	✓ Murraming and construction of slabs has not	✓ Slabs need to be constructed ✓ A sitting bench should also be constructed

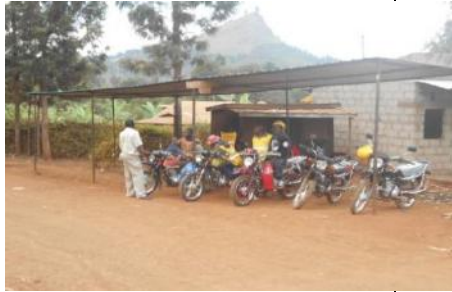
<ul style="list-style-type: none"> been done ✓ No sits have been put in place 	
Kairungu boda boda shed

0.00		<ul style="list-style-type: none"> ✓ The bodaboda shed is complete 	<ul style="list-style-type: none"> ✓ Murraming and construction of slabs has not been done ✓ No sits have been put in place 	<ul style="list-style-type: none"> ✓ Slabs need to be constructed and put in place ✓ The shed needs a slanting front roof ✓ There is need for a floodlight
Nembure waiting bay

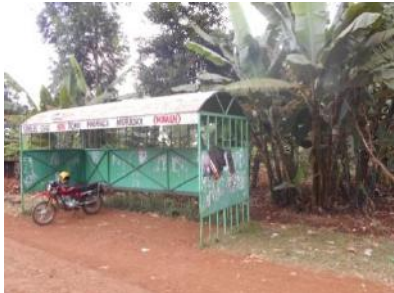
0.00		<ul style="list-style-type: none"> ✓ The project is complete and in use 	<ul style="list-style-type: none"> ✓ The 2 stages are in good condition ✓ No proper lighting of the place 	<ul style="list-style-type: none"> ✓ A floodlight is required at site
INFRASTRUCTURE, PUBLIC WORKS, HOUSING AND ENERGY					
Karurina access road	0.00		<ul style="list-style-type: none"> ✓ The project is in poor condition 	<ul style="list-style-type: none"> ✓ Grading has been done ✓ Murraming of the road 	<ul style="list-style-type: none"> ✓ Murraming should be redone

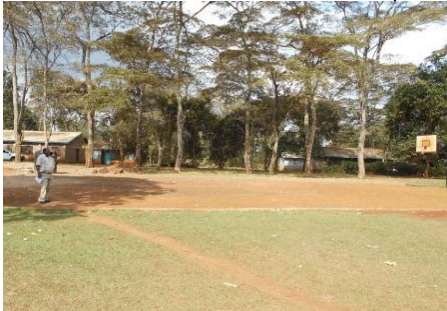
0.00		✓ The field is still under construction	✓ 2 rims have been installed ✓ The court is still uncemented	✓ The court needs to be cemented and marked appropriately
Nembure Sports ground pavilion	4,000,00 0.00		✓ The project	✓ Only one	✓ There is need for a

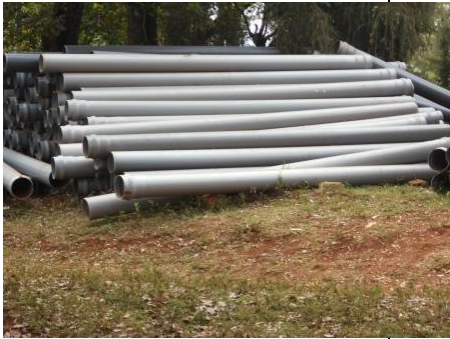
5,000,00		✓ The pipes for the project have already been purchased	✓ 12' pipes have been placed next to the Nembure Agricultural Extension office	<ul style="list-style-type: none"> ✓ The pipes should be installed ✓ A 2nd tranche has been allocated in FY 2017/18 towards the implementation of the water project

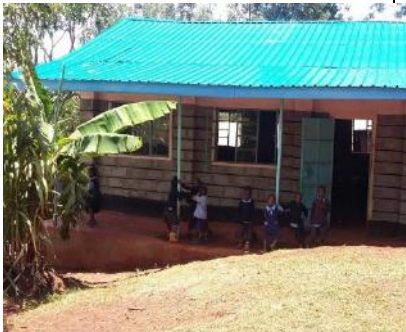
Project Description	Allocation 2017/18	Expenditure	Status	Observations	Recommendations
					<ul style="list-style-type: none"> ✓ Water tanks and gutters should be intalled
<p>Igumo ECDE</p>

0.00	-	<ul style="list-style-type: none"> ✓ The construction of ECDE centre is complete 	<ul style="list-style-type: none"> ✓ The is also need to allocate more funds towards construction of a 2nd classroom to cater for the 70 plus population of ECDE going children 	<ul style="list-style-type: none"> ✓ The school has a total of 3 teachers for the ECDE. ✓ One of the teachers is paid by parents hence the need to have them paid by the County Government

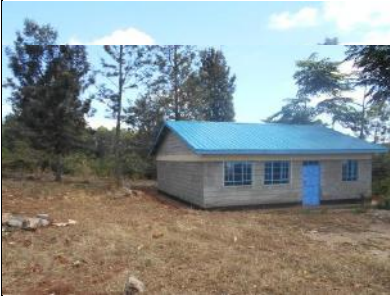
Project Description	Allocation 2017/18	Expenditure	Status	Observations	Recommendations
EDUCATION, SCIENCE AND TECHNOLOGY					
Kithimu polytechnic 1. Instruction rooms

1,000,000.00		<ul style="list-style-type: none"> ✓ The instruction rooms are complete with 2 classrooms and 2 offices ✓ The kitchen is complete with a food store, cooking area and an office ✓ The staff and student toilets are complete 	<ul style="list-style-type: none"> ✓ 3 acres of land was purchased for the construction ✓ Instruction room electrical piping is in place but the wiring has not been done ✓ There is no water connection and electrical installation in the kitchen ✓ There are 2 female toilets and 1 male toilet plus a urinal for both staff and students 	<ul style="list-style-type: none"> ✓ Needs electrical and water connectivity ✓ Landscaping and levelling of the playing ground is needed ✓ There is need for a workshop ✓ A perimeter fence and as a gate should be put in place ✓ A signage for the facility should be put in place ✓ There is need for equipment and furniture to be provided for the institution ✓ The kitchen requires water connection

Project Description	Allocation 2017/18	Expenditure	Status	Observations	Recommendations
					✓ Kitchen equipment needs to be purchased and installed Note: KES. 1,000,000 has been allocated in FY 2017/18 for installation Of Three Phase Electricity Power
St. Andrews ECDE classroom

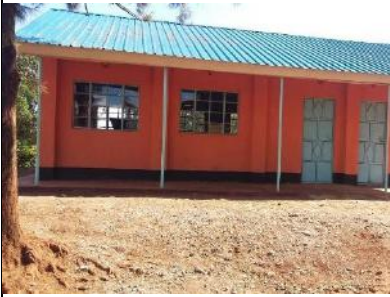
0.00		Construction is 100% complete pending equipping with furniture	Construction works of this particular ECDE centre is of very high quality.	✓ This particular Contractor is recommended highly to the County Government for any future works.
AGRICULTURE & IRRIGATION, LIVESTOCK, FISHERIES AND CO-OPERATIVE DEVELOPMENT

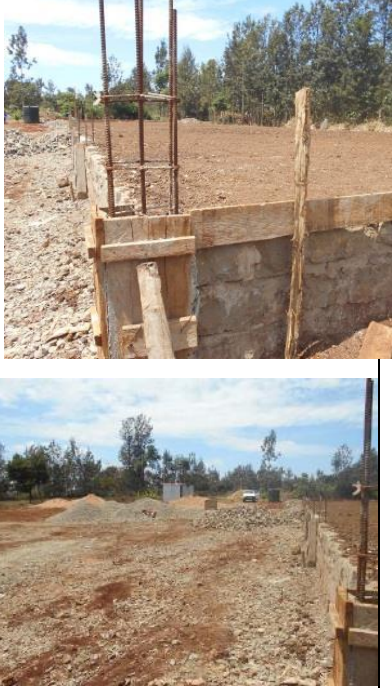
10,000,000.00		<ul style="list-style-type: none"> ✓ Construction of facility is ongoing 	<ul style="list-style-type: none"> ✓ The materials are on site ✓ The facility is at foundation level ✓ 2 acres of land had been purchased for the project 	<ul style="list-style-type: none"> ✓ A perimeter fence and a gate need to be constructed ✓ There is need for signage at the project site
Kithimu livestock market

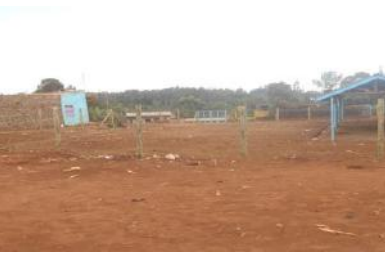
0.00		<ul style="list-style-type: none"> ✓ Market construction is complete 	<ul style="list-style-type: none"> ✓ A perimeter fence has been erected ✓ A gate has been constructed 	<ul style="list-style-type: none"> There is need to expand the market due to the huge number of sellers
TRADE, TOURISM, INVESTMENT AND INDUSTRIALIZATION					
Ndatu open air market

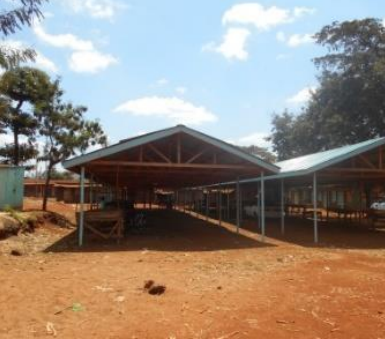
150,000.00		<ul style="list-style-type: none"> ✓ Market construction is complete 	<ul style="list-style-type: none"> ✓ There is poor lighting in the market at night 	<ul style="list-style-type: none"> ✓ Murraming should be done at the market ✓ A perimeter fence should be constructed ✓ A gate should be

Project Description	Allocation 2017/18	Expenditure	Status	Observations	Recommendations
					constructed Note: Kes. 150,000 has been allocated in FY 2017/18 towards lighting of the market
Ndatu market toilet

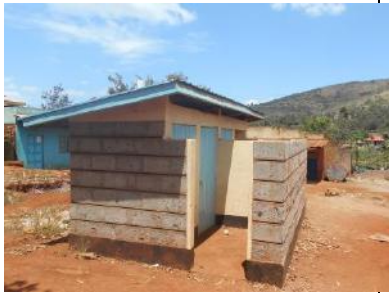
0.00		✓ The toilets are operational	<ul style="list-style-type: none"> ✓ There are 3 toilets (2 female and 1 for male) + 1 urinal ✓ The toilets are in use 	✓ The project is complete
Ndatu floodlights	0.00		✓ The project is complete	<ul style="list-style-type: none"> ✓ The bulbs are in good working conditions 	✓ Trees need to be pruned for maximum lighting
Ndatu boda boda shed

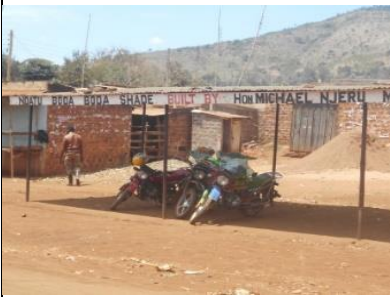
0.00		✓ The shed is in use with over 60 motorcycles	<ul style="list-style-type: none"> ✓ There is no siting area ✓ The floor is not murrammed 	<ul style="list-style-type: none"> ✓ There is need for a second shed ✓ Murramm ing needs to be done at the shed ✓ One steel support needs to

Project Description	Allocation 2017/18	Expenditure	Status	Observations	Recommendations
					<ul style="list-style-type: none"> be repaired ✓ A sitting area to be constructed
Rukira bodaboda shed

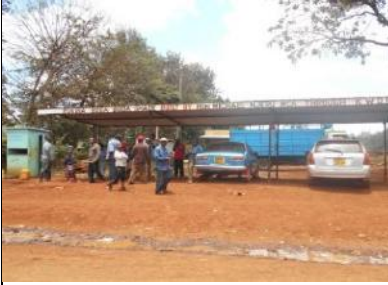
0.00		<ul style="list-style-type: none"> ✓ The shed is in use by over 25 motorists 	<ul style="list-style-type: none"> ✓ There is no resting/sitting place ✓ 	<ul style="list-style-type: none"> ✓ Murraming of floor needs to be done ✓ A sitting bench should be constructed
Rukira market floodlight

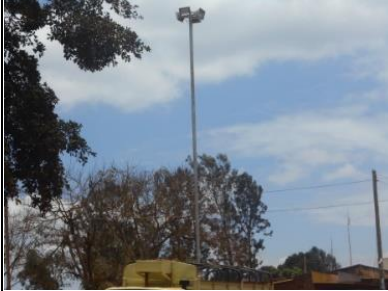
0.00		<ul style="list-style-type: none"> ✓ The project is not operational 	<ul style="list-style-type: none"> ✓ 	<ul style="list-style-type: none"> ✓ The lights needs to be repaired
Rukira market toilet	0.00		<ul style="list-style-type: none"> ✓ The project is complete 	<ul style="list-style-type: none"> ✓ the market toilets are in use (2 toilets +urinal)

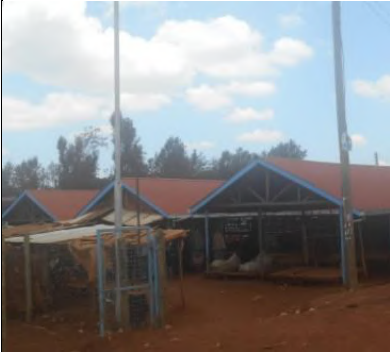
<p data-bbox="203 842 496 869">Kithimu open air market</p>

<p data-bbox="878 842 1032 1010">✓ The project is complete</p>	<p data-bbox="1057 842 1211 1045">✓ The market has been fenced and gated</p> <p data-bbox="1057 1052 1211 1192">✓ The floor has been murramed</p> <p data-bbox="1057 1199 1211 1367">✓ The market is operational</p>	<p data-bbox="1242 842 1396 1052">✓ There is need to install lighting in the facility</p> <p data-bbox="1242 1058 1396 1367">✓ Kes. 150,000 has been allocated in FY 2017/18 towards installation Of lights</p>
HEALTH					
<p data-bbox="203 1593 548 1661">Kithegi dispensary maternity wing</p>	<p data-bbox="589 1593 721 1661">2,500,000.00</p>		<p data-bbox="878 1593 1032 1761">✓ the project is complete</p>	<p data-bbox="1057 1593 1211 1734">✓ Electrification has been done</p> <p data-bbox="1057 1740 1211 1873">✓ water tank has been supplied</p>	<p data-bbox="1242 1593 1396 1761">✓ Fencing is needed and a gate to be put in place</p> <p data-bbox="1242 1768 1396 1873">✓ A water connection is</p>

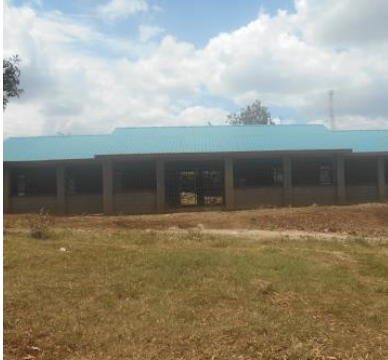
Project Description	Allocation 2017/18	Expenditure	Status	Observations	Recommendations
<p data-bbox="204 268 464 331">Kithimu health center outpatient block</p>

<p data-bbox="589 268 716 331">10,500,000.00</p>		<p data-bbox="878 268 1032 405">✓ Construction is still ongoing</p>	<p data-bbox="1057 268 1211 405">✓ The contract or is not on site</p> <p data-bbox="1057 411 1211 548">✓ The ceiling is not installed</p> <p data-bbox="1057 554 1211 722">✓ Window panes have been installed</p> <p data-bbox="1057 728 1211 865">✓ Wiring has not been done</p> <p data-bbox="1057 871 1211 1039">✓ Internal doors have not been installed</p> <p data-bbox="1057 1045 1211 1255">✓ The waiting bay has no window panes</p>	<p data-bbox="1242 268 1422 541">✓ The department to follow up the project to completion</p> <p data-bbox="1242 548 1422 722">Note: Funds have been allocated in FY 2017/18 towards:</p> <ol data-bbox="1291 728 1422 1335" style="list-style-type: none"> <li data-bbox="1291 728 1422 947">1. Completion of facility – 2,500,000 <li data-bbox="1291 953 1422 1142">2. Construction of staff houses 6,000,000 <li data-bbox="1291 1148 1422 1335">3. Equipping of OPD block – 2,000,000

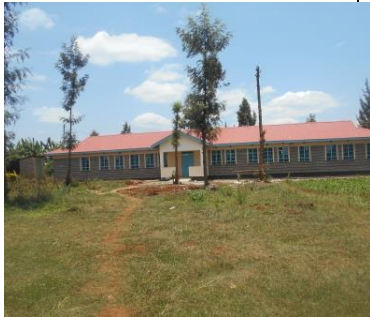
2,000,000		✓ Constructions are still ongoing	✓ Roofing and walling has been done ✓ Painting has not been fully done ✓ Floor tiles have been put in place ✓ Electrical connectivity has not been done	✓ Internal door and window handles are pending to be fixed ✓ The structure is awaiting final finishings and paintings Note: Kes. 2,000,000 has been allocated in FY 2017/18 towards equipping of facility
Kangaru dispensary

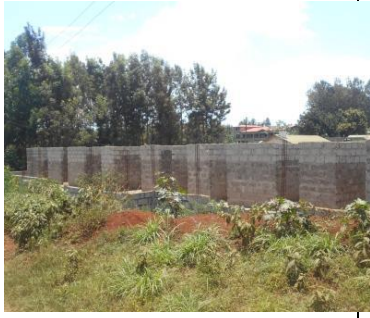
6,000,000.00		✓ Construction is ongoing	✓ Contractor was not on site ✓ Phase one of the project is complete ✓ Walling substructure done	✓ Toilets need to be constructed ✓ A perimeter fence is needed ✓ There is need to fast-track the implementation Note: Enough funds have been allocated in FY 2017/18 towards completion of facility

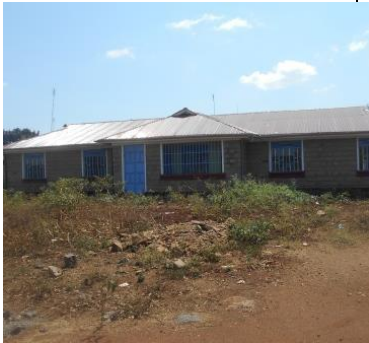
Project Description	Allocation 2017/18	Expenditure	Status	Observations	Recommendations
<p>Majengo children rescue centre</p>

2,556,132.00		<ul style="list-style-type: none"> ✓ The project is complete 	<ul style="list-style-type: none"> ✓ The building is complete ✓ A perimeter fence and gate has been constructed 	<ul style="list-style-type: none"> ✓ Landscaping needs to be done ✓ The center requires landscaping ✓ Water and electricity need to be connected <p>Note: Funds have provided towards equipping of facility</p>
<p>Dallas dispensary</p>

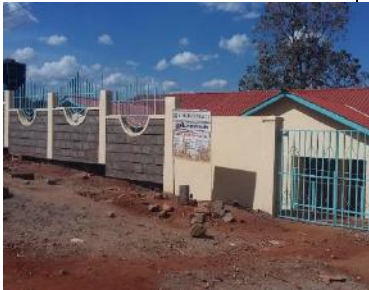
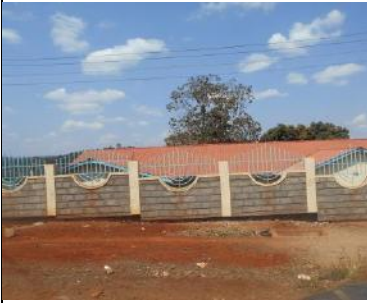
2,000,000.00		<ul style="list-style-type: none"> ✓ Renovation of maternity wing ✓ Construction of perimeter wall 	<ul style="list-style-type: none"> ✓ Renovation of maternity wing has been completed ✓ Construction of a wall has been done ✓ Construction of a waiting area has been done 	<ul style="list-style-type: none"> ✓ Funds have been allocated towards equipping of maternity

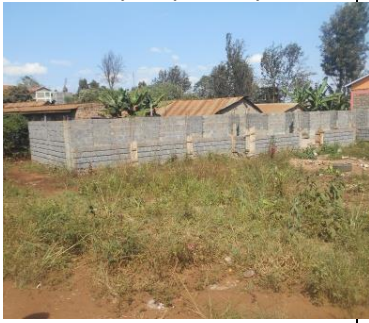
4,000,000.00		✓ The project is ongoing	✓ The substructure is in place ✓ Contract or not on site ✓	✓ Toilets need to be constructed ✓ Fencing needs to be put in place ✓ Funds have been allocated towards completion of facility
EDUCATION, SCIENCE AND TECHNOLOGY					
Kangaru polytechnic dormitory (girls)

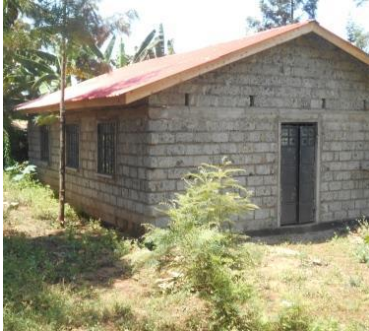
✓ Phase one of the project is complete	✓ Contract or not on site ✓ Doors and windows have been installed ✓ It hosts 25 girls	✓ A mechanic workshop is required ✓ Landscaping needs to be done ✓ A kitchen needs to be constructed Note: Funds have been allocated towards completion under Conditional Allocation For Development Of Youth Polytechnics (Vocational Training Centers Works)

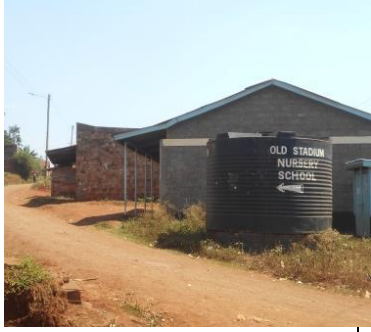
0.00		✓ The project is not operational	✓ There are no toilets ✓ There is no perimeter fence	✓ Toilets need to be constructed ✓ A perimeter wall should be put in place
Dallas ECDE centre

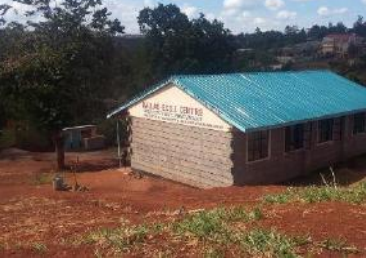
0.00		✓ The ECDE centre is complete	✓ The facility is operational	
YOUTH EMPOWERMENT AND SPORTS

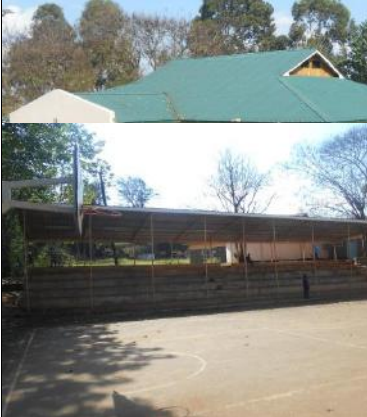
13,500,000		<ul style="list-style-type: none"> ✓ Renovation of talent academy ✓ Construction of basketball pitch and pavilion ✓ Construction of gate ✓ Renovation of perimeter wall 	<ul style="list-style-type: none"> ✓ Construction of pavilion and basketball pitch complete ✓ Renovation of fence and metallic gate is complete 	<ul style="list-style-type: none"> ✓ Landscaping should be done ✓ An ablution block is needed ✓ Caprock should be erected on the compound outside talent academy <p>Note: Funds have been allocated in FY 2017/18 as follows</p> <ol style="list-style-type: none"> 1. Talent Academy Improvement – 7,500,000 2. Purchase of equipment – 6,000,000

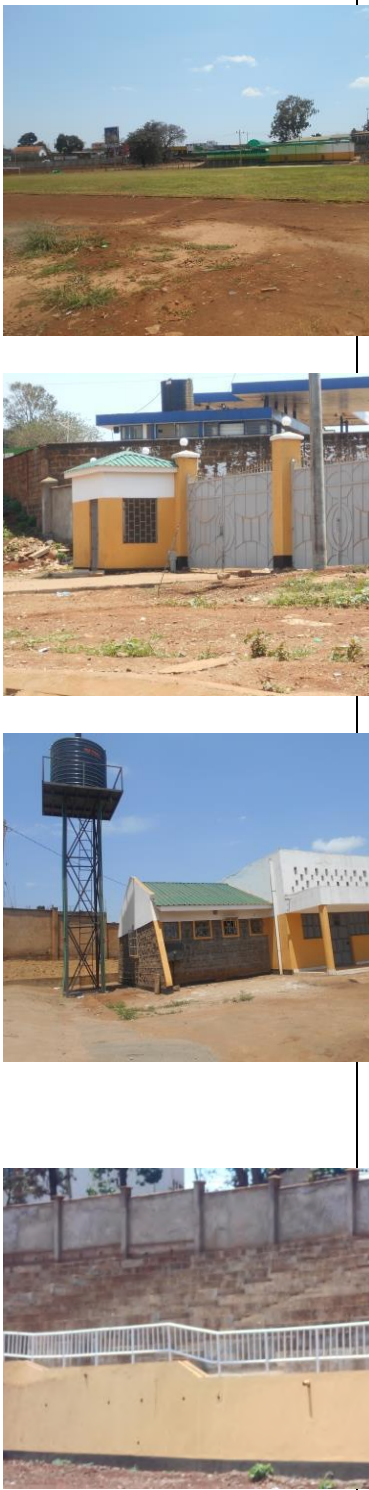
13,500,000	86,467,134.00	✓ The project is ongoing	<ul style="list-style-type: none"> ✓ It has 2 tanks in place ✓ There is an issue with water drainage ✓ Sitting areas(terraces) have been done to completion ✓ There is a fence in place both internally and externally ✓ Floodlights have been installed ✓ Goal posts have been put in place ✓ A VIP dias has been constructed(a section of the roof was ripped off by strong winds) 	<ul style="list-style-type: none"> ✓ A canopy should be placed above the terraces ✓ Electrical connectivity should be done ✓ There is need to replace the ceiling and the roof ✓ A detailed assessment is required to determine extent of damage <p>Note: Funds have been allocated in FY 2017/18 towards stadium maintenance, improvement and refurbishment</p>

Project Description	Allocation 2017/18	Expenditure	Status	Observations	Recommendations
				<ul style="list-style-type: none"> ✓ The main gate was constructed with a security house ✓ Ceiling in place but is leaking ✓ Changing rooms with metallic wardrobes have been purchased ✓ Has 5 gates (1 main, 3 medium and 1 minor gateminor) 	
GENDER, CULTURE AND SOCIAL SERVICES					
Dallas resource centre	0.00		✓ The construction is	✓ Landscaping has	✓ Toilets need to be constructed

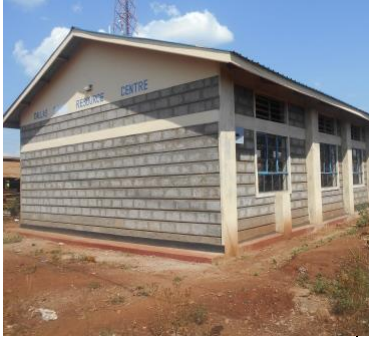
complete	not been done ✓ There is no water and electrical connection	d for both male and female ✓ A perimeter fence and gate should be constructed ✓ Electrical and water connections should be installed
<p>Cultural centre</p> <p>1. Museum</p>

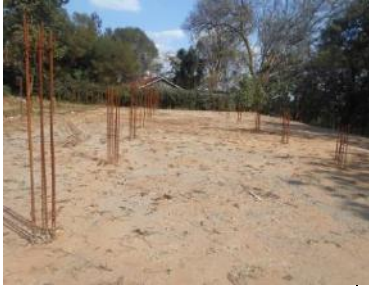
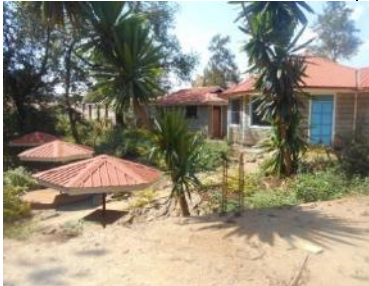
✓ The project is complete	✓ The sitting area has been done ✓ The ablution block has been completed ✓ Kitchen has been constructed ✓ The museum foundation has been done.	✓ The project should be allocated enough resources to completion
